MEMOIRS OF THE
ARCHAEOLOGICAL SURVEY OF INDIA
NO. 91

ANGKOR VAT

INDIA'S CONTRIBUTION IN CONSERVATION

1986-1993

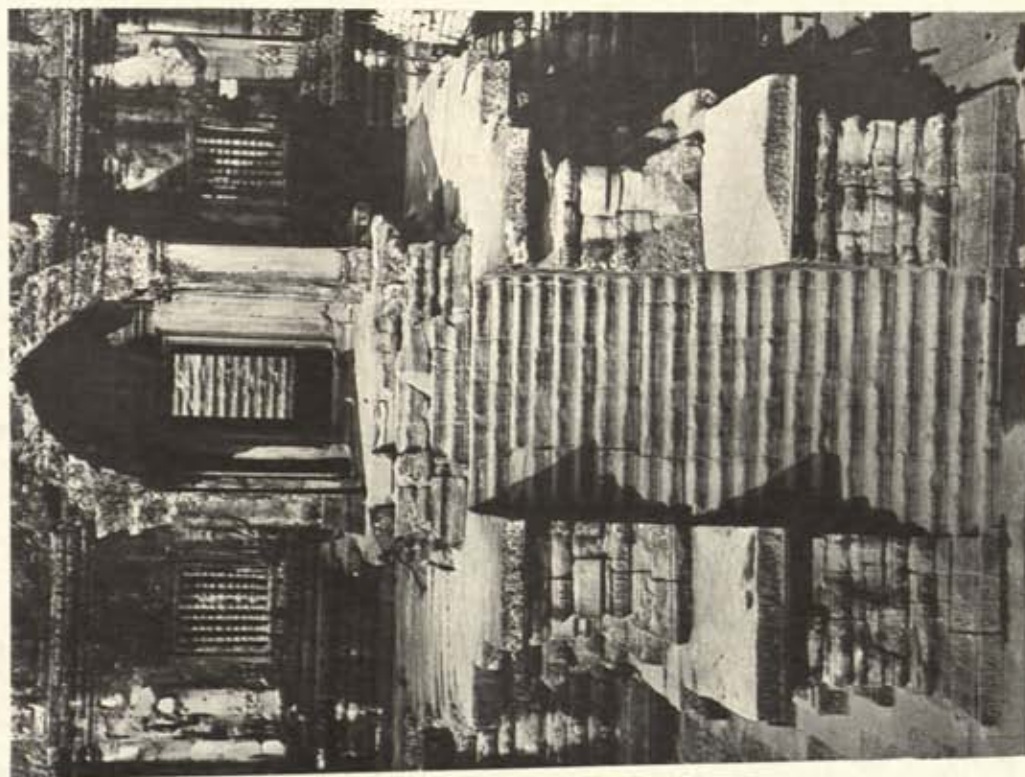
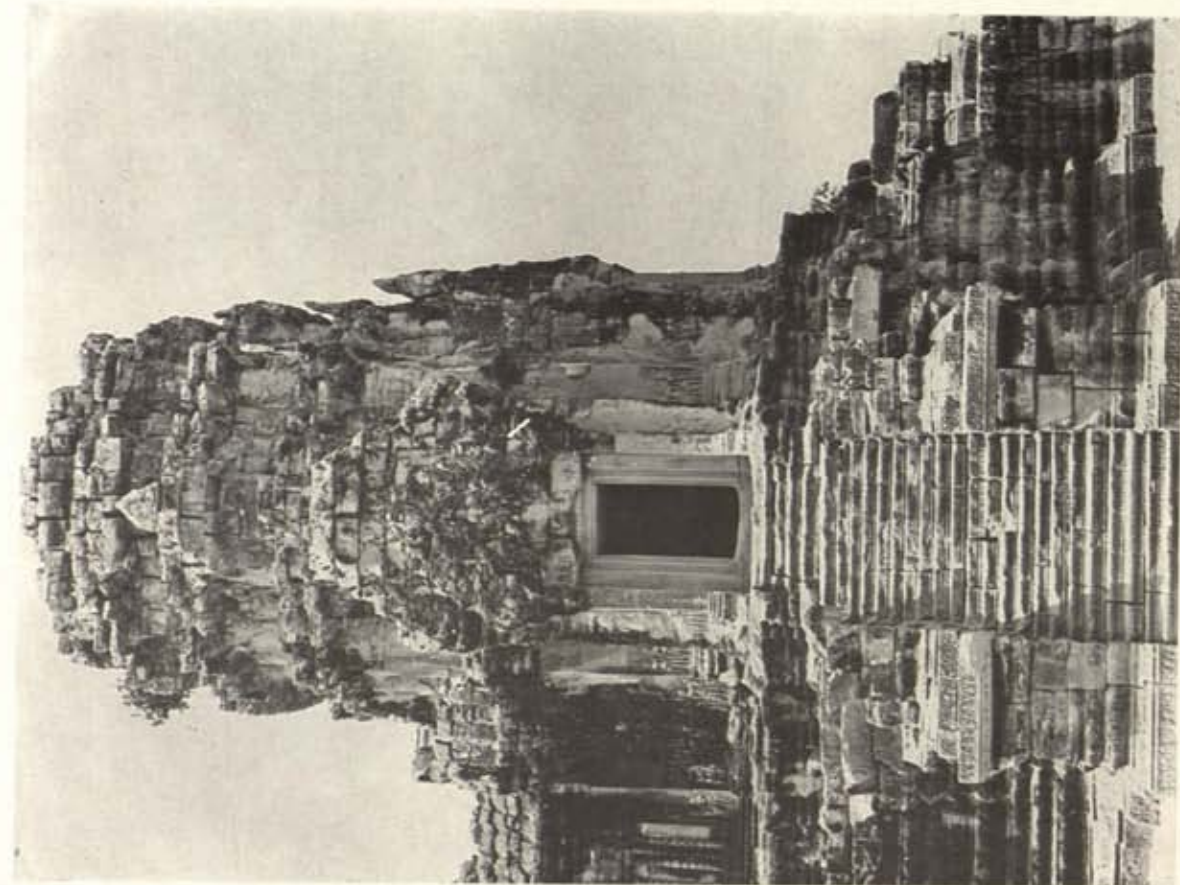
Second Enclosure : eastern central entrance , A, before and B, after conservation

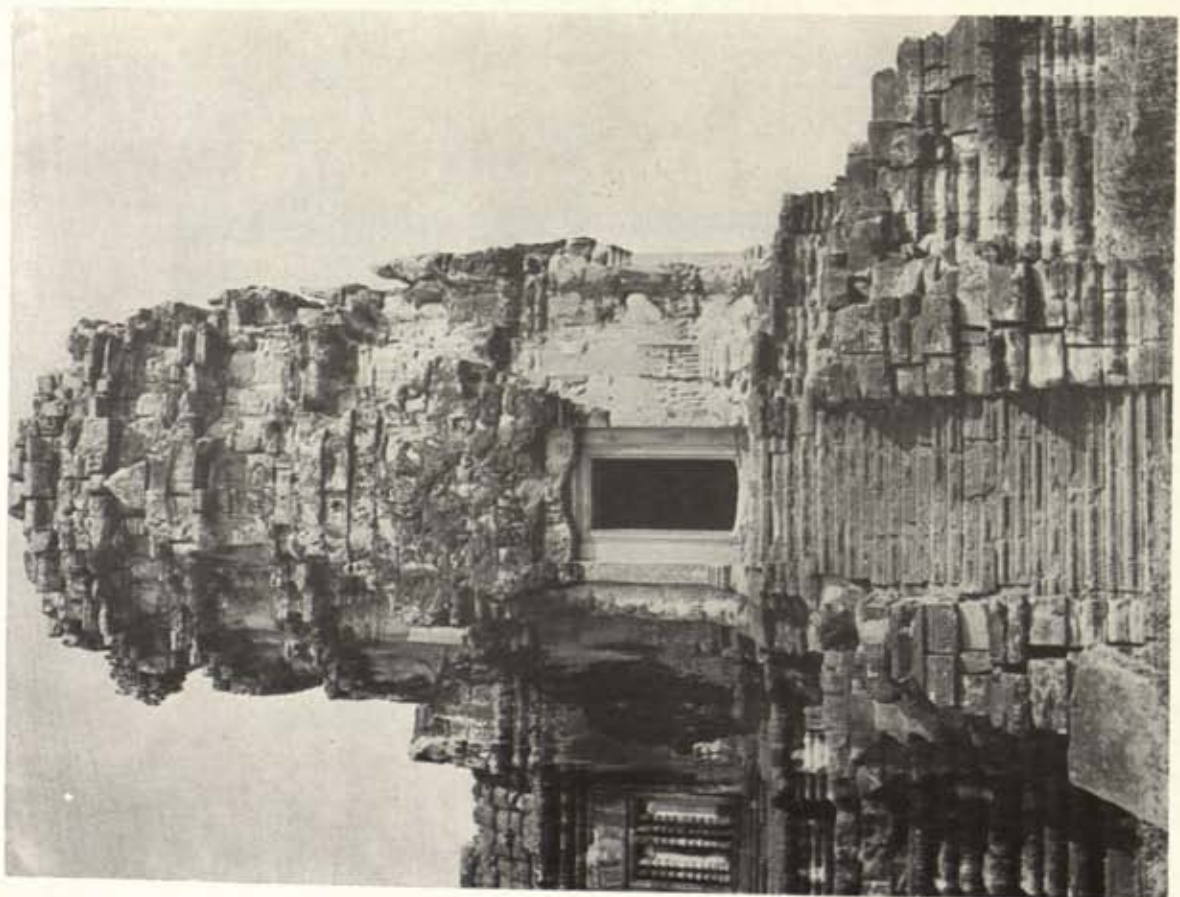
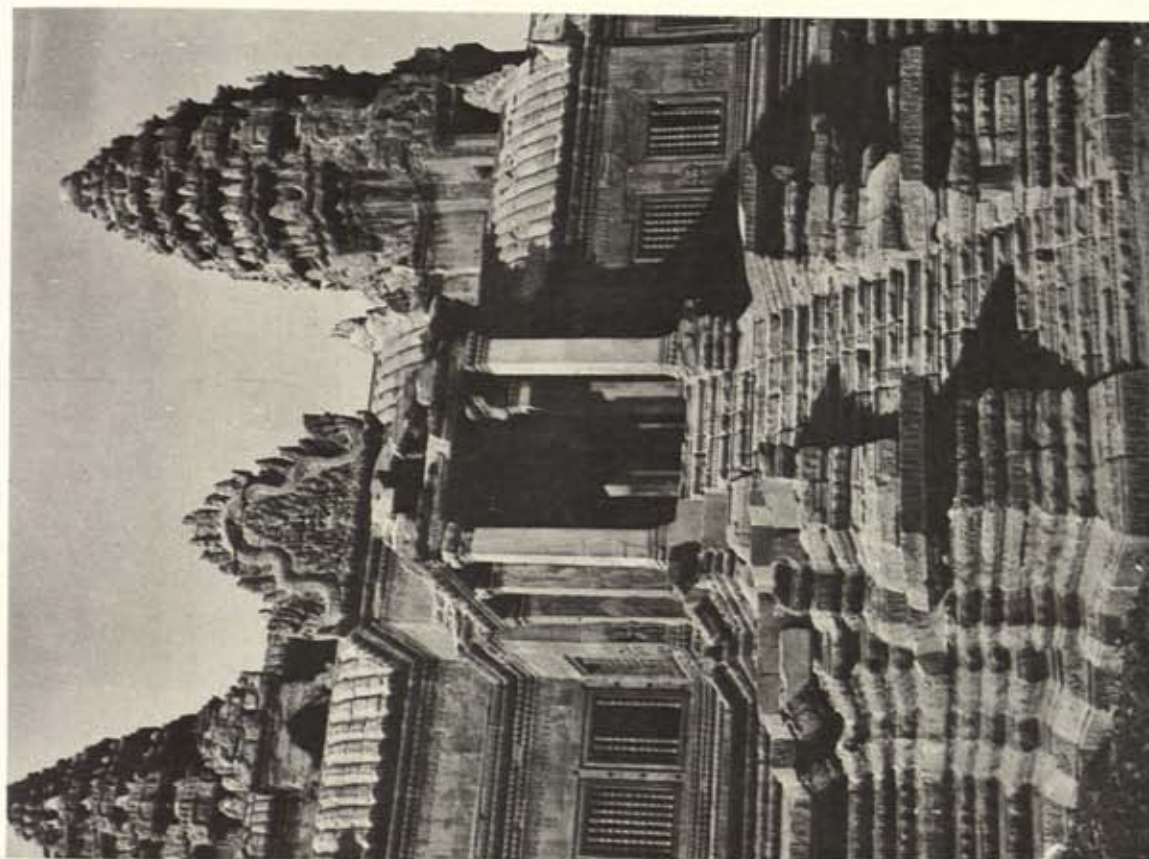
Second Enclosure; southern entrance at east corner, A, before and B, after conservation

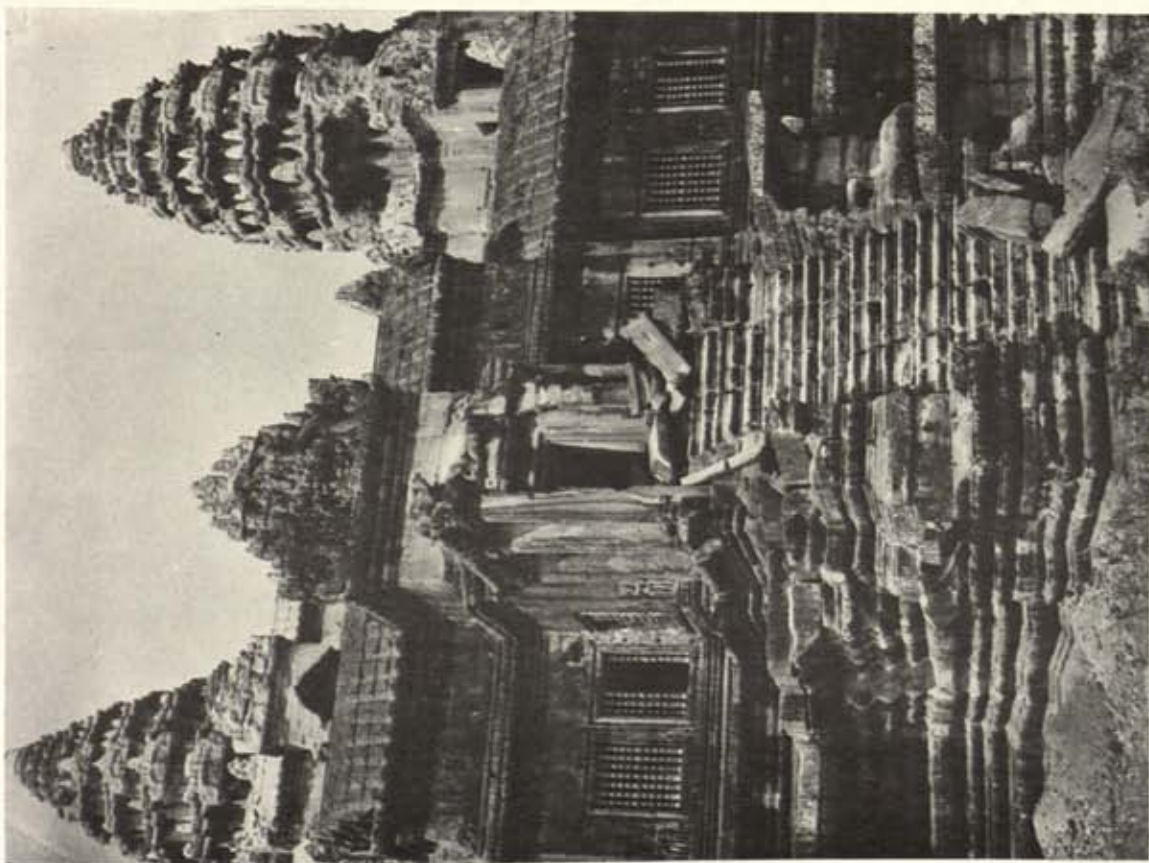
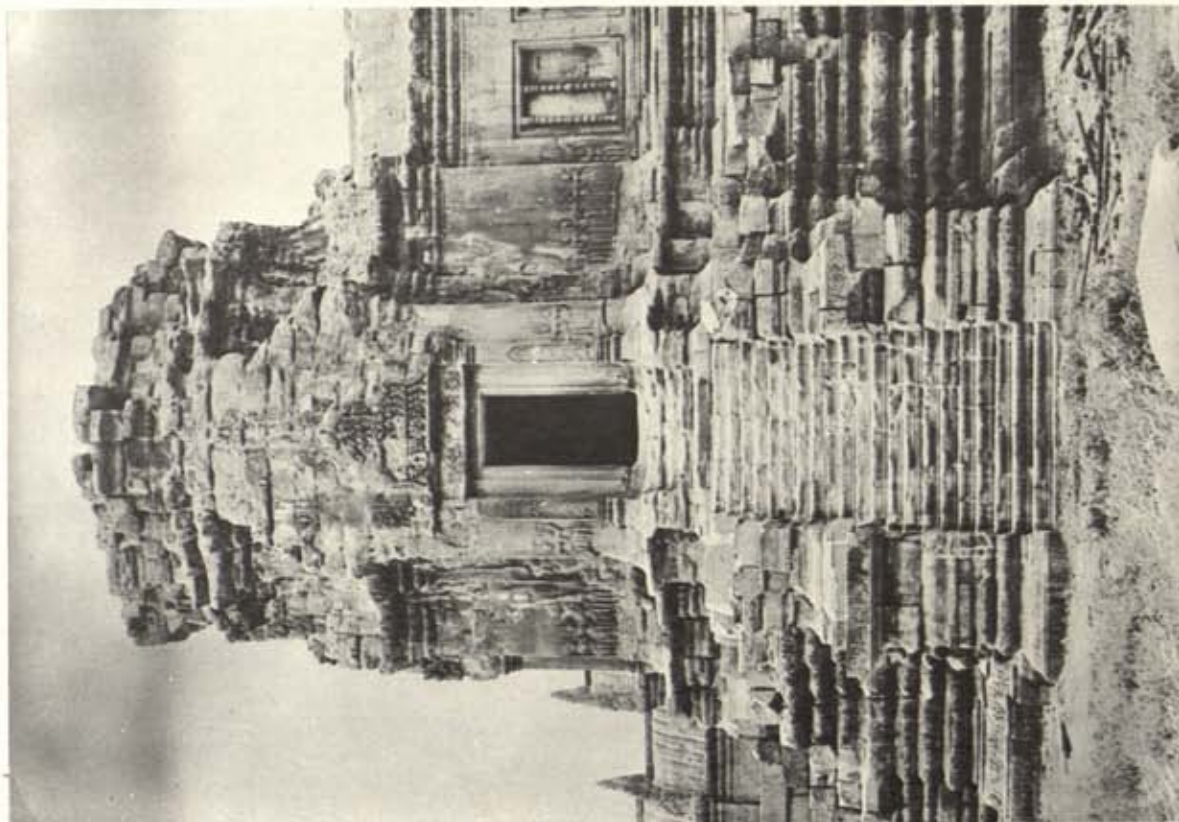
Second Enclosure : southern central entrance. A, before and B, after conservation

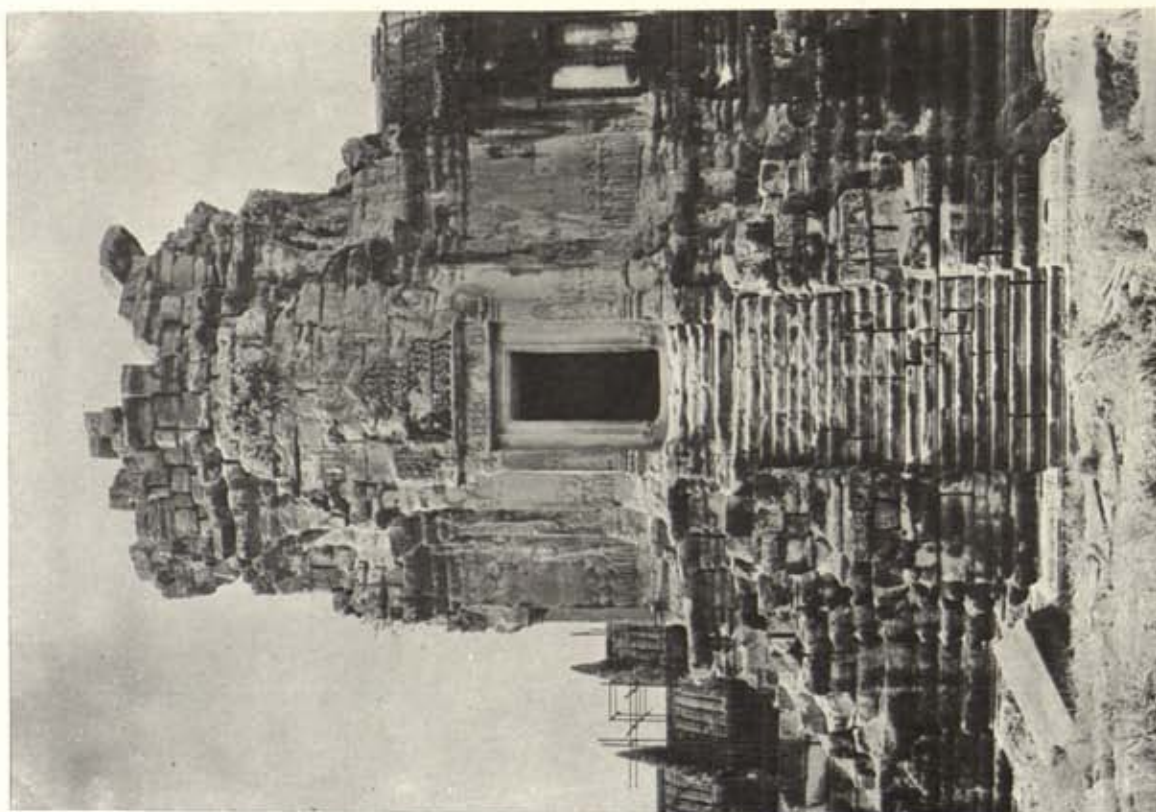
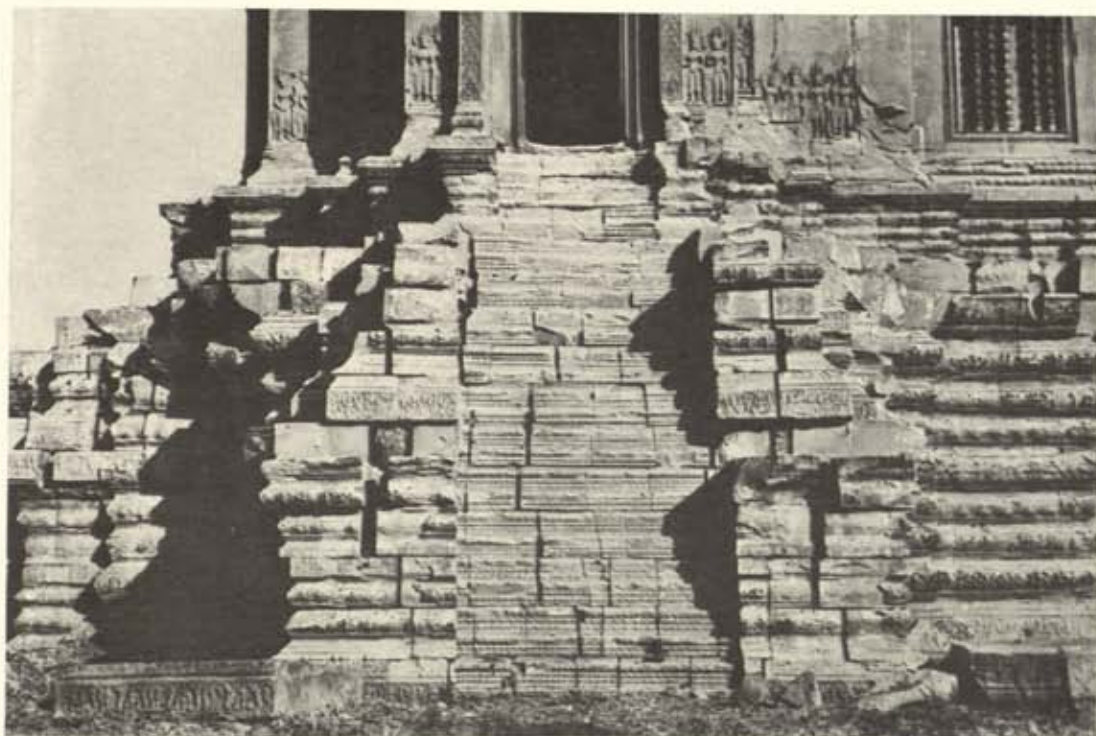
Second Enclosure : southern entrance at west corner, A, before and B, after conservation

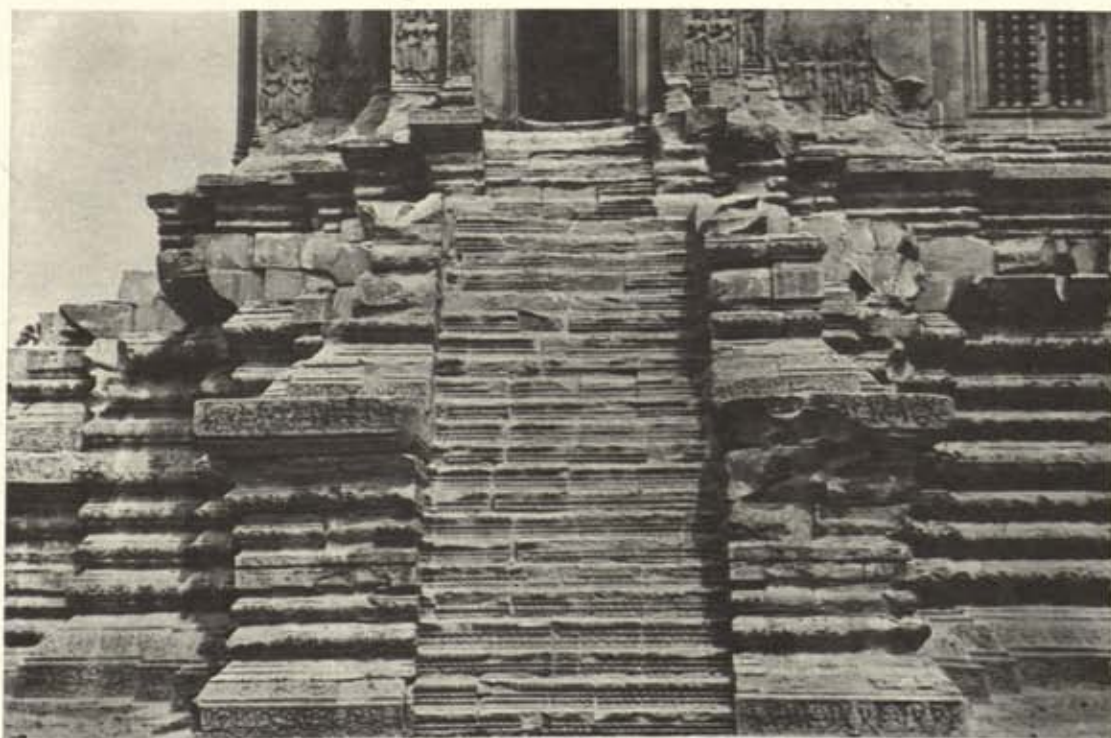
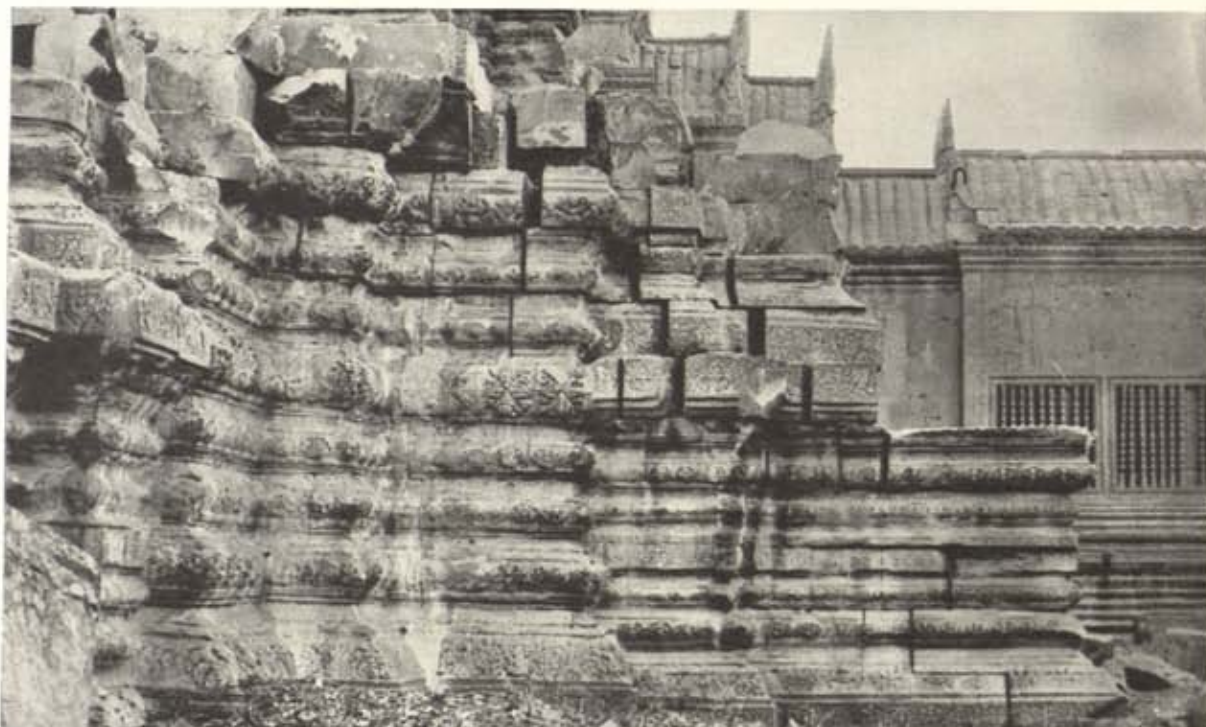
Second Enclosure : western entrance at south corner, A, before and B, after conservation

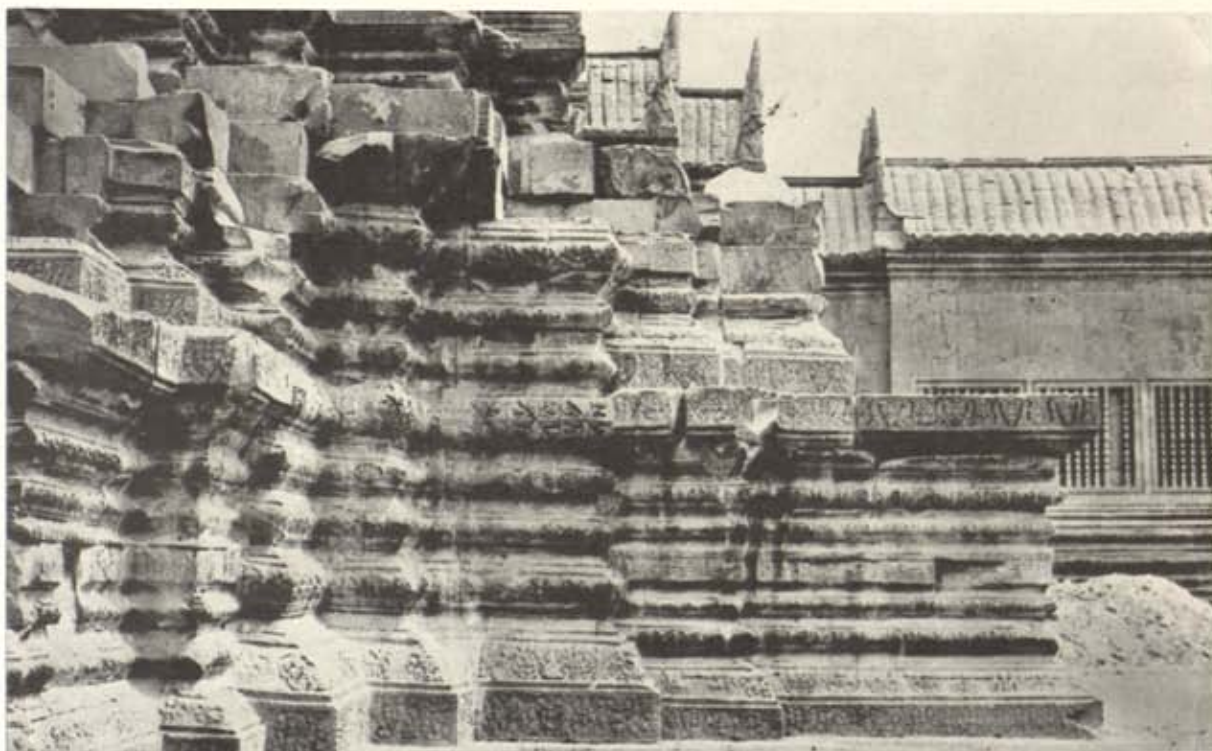
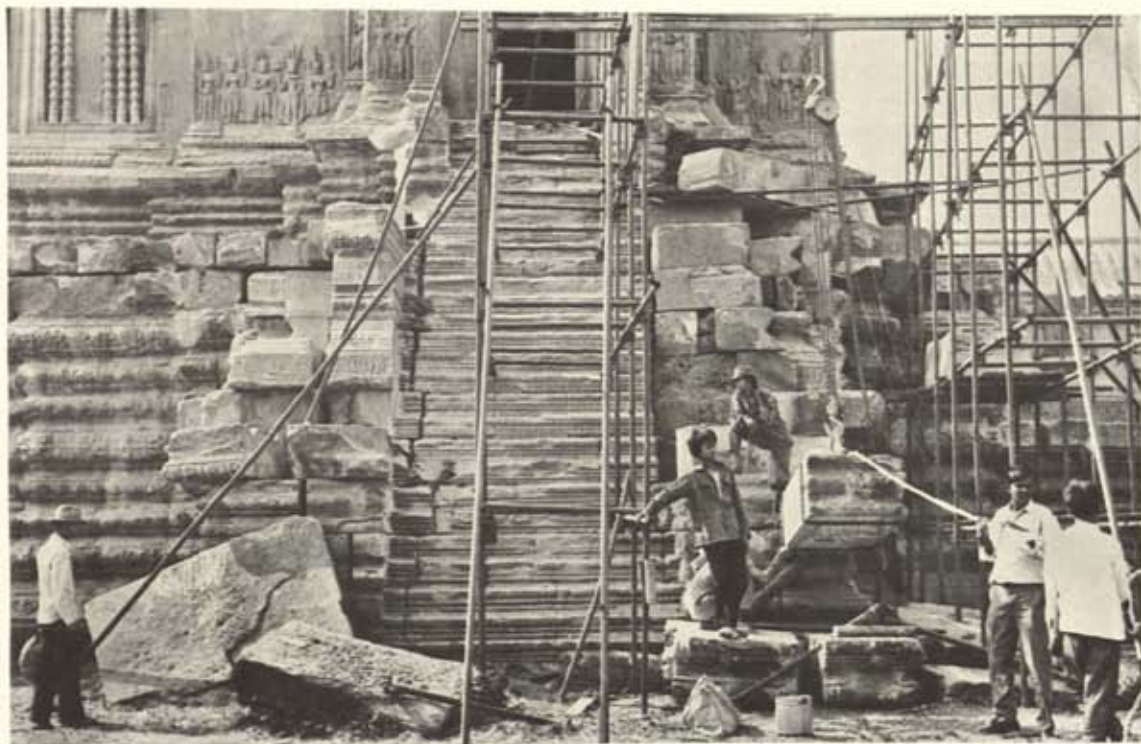
Second Enclosure : western entrance at north corner, A, before and B, after conservation

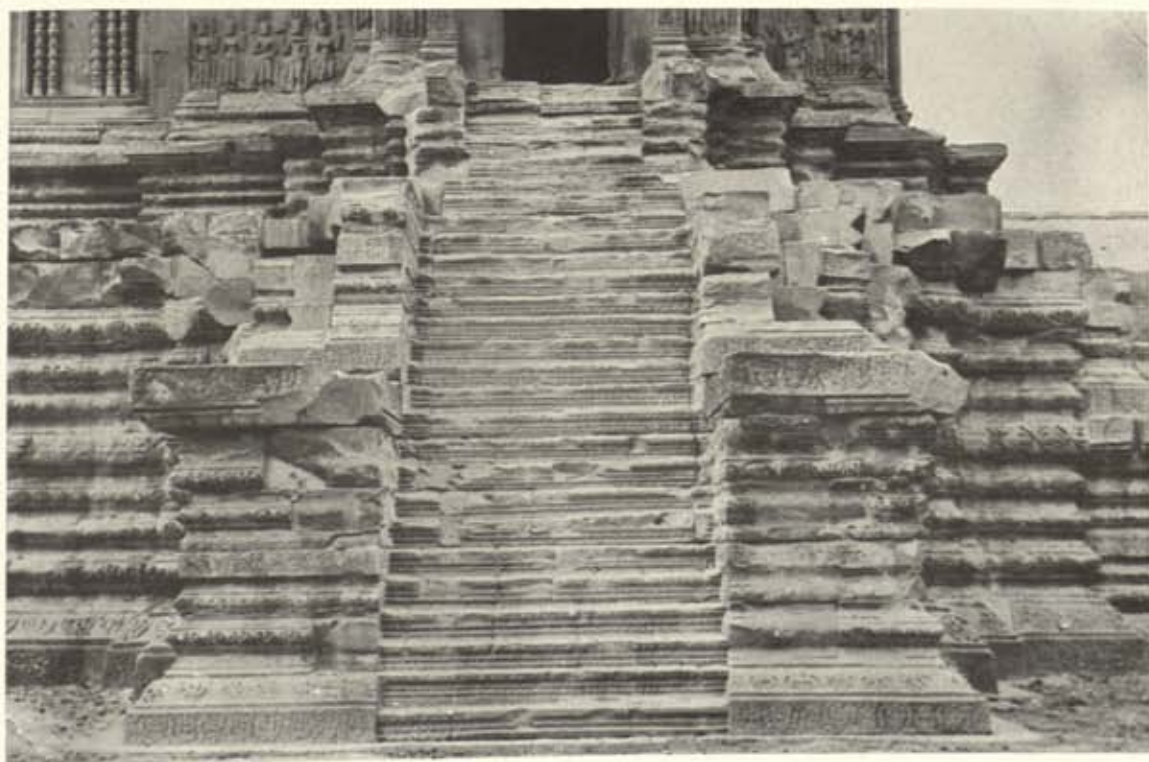
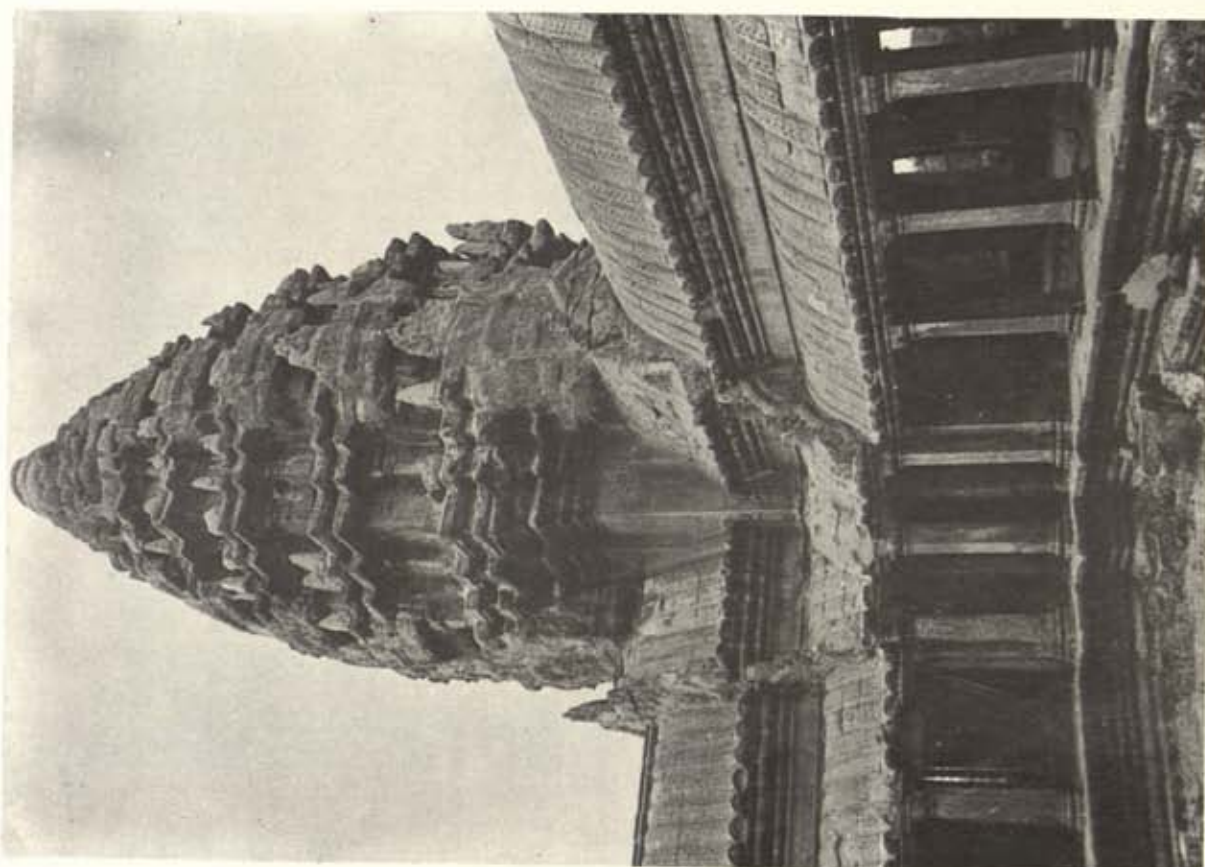
Second Enclosure : northern entrance at west corner, A, before and B, after conservation

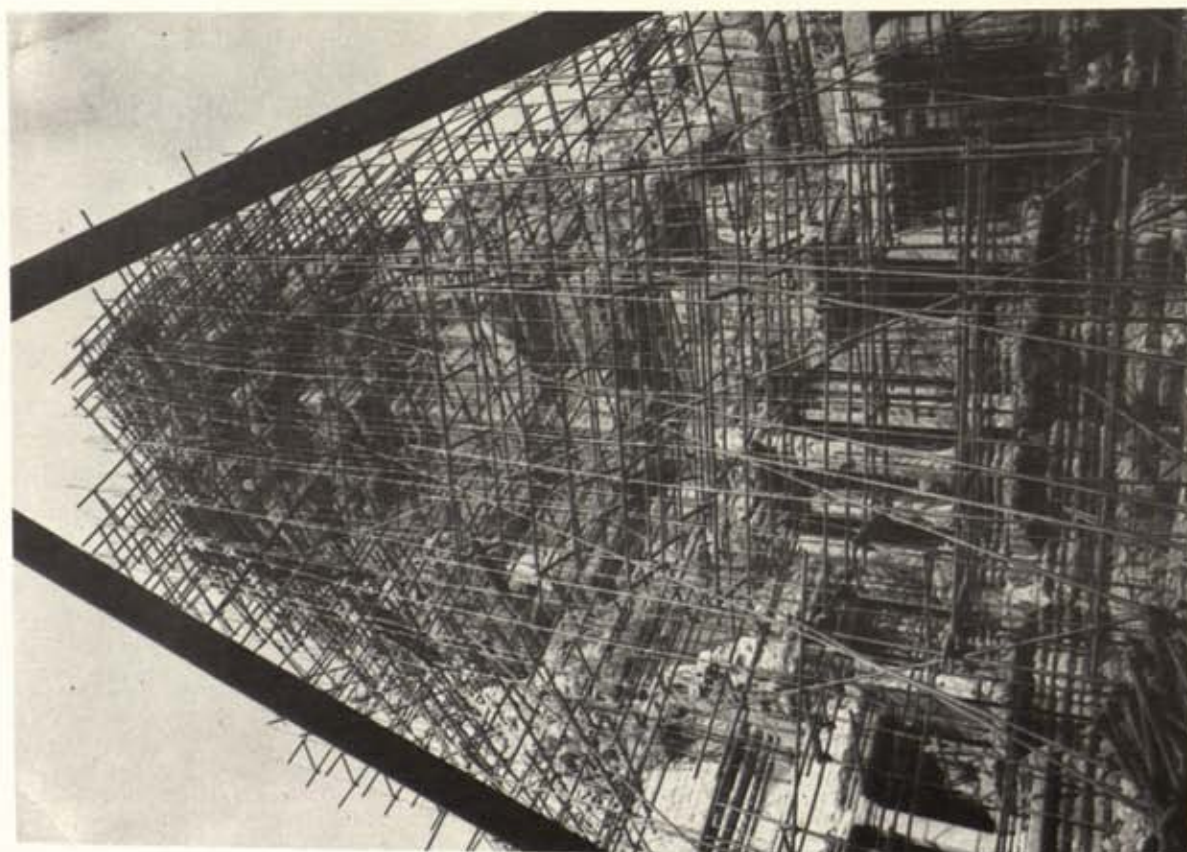
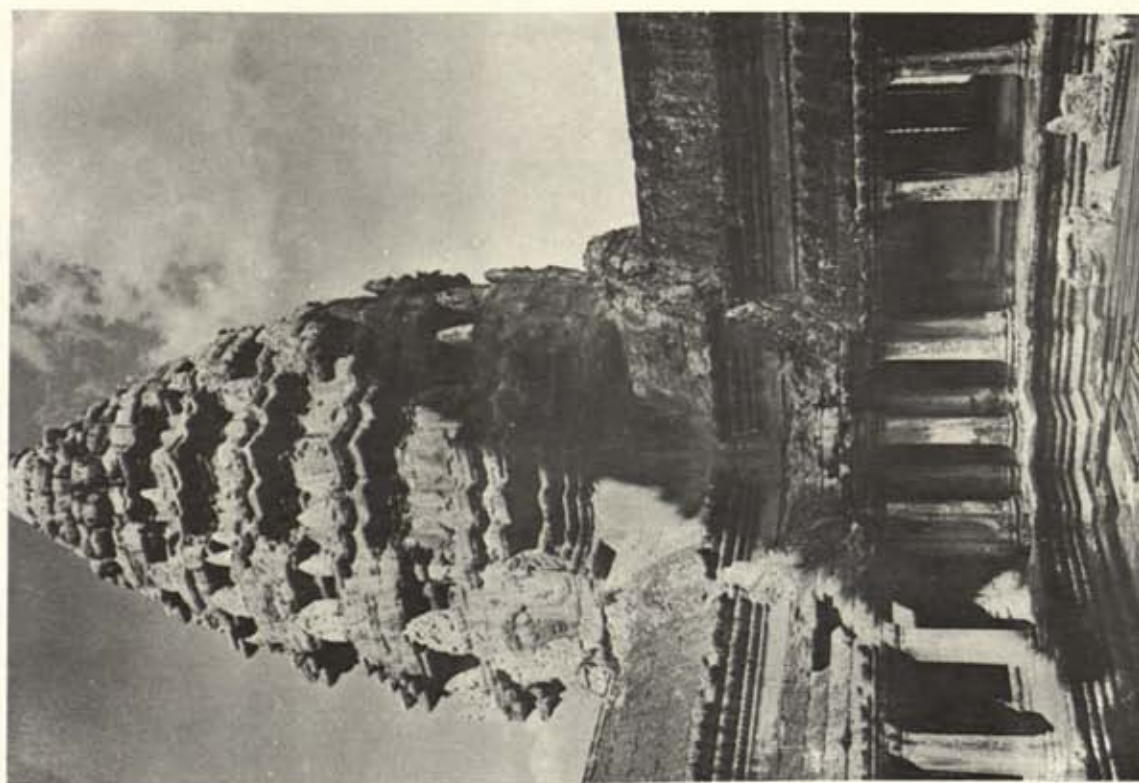
First Enclosure : central tower, A, during and B, after conservation and chemical treatment

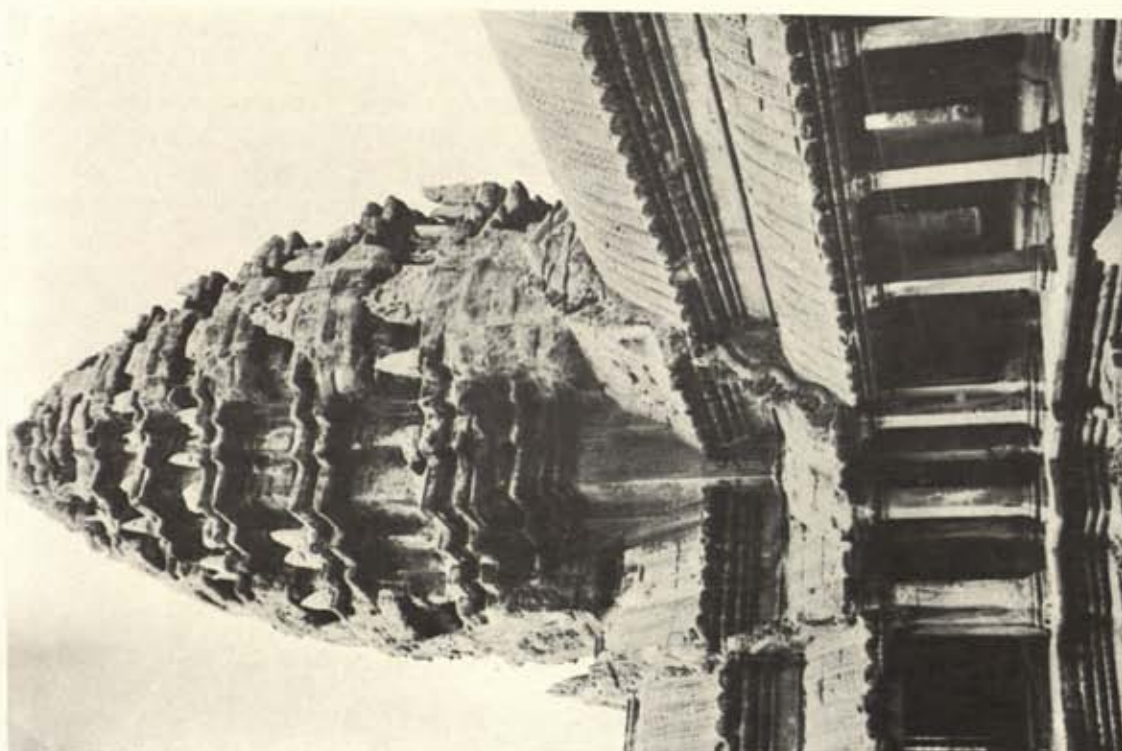
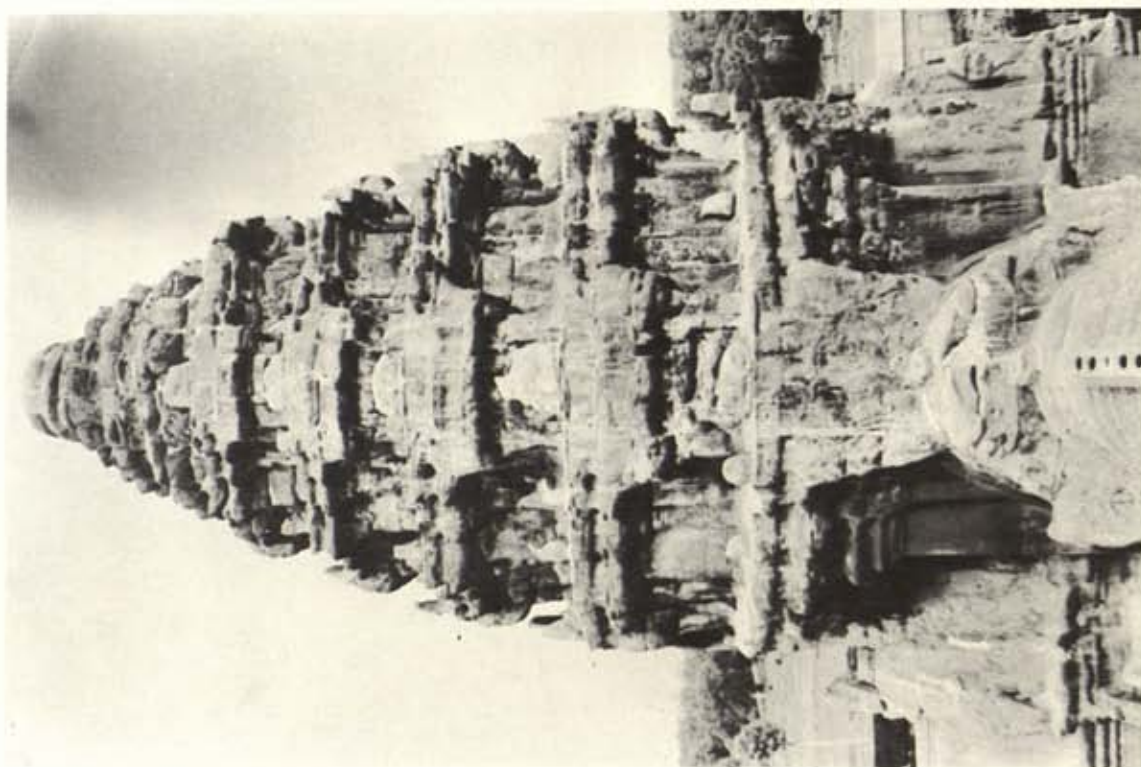
First Enclosure : north-east tower, A, before and B, after conservation and chemical treatment

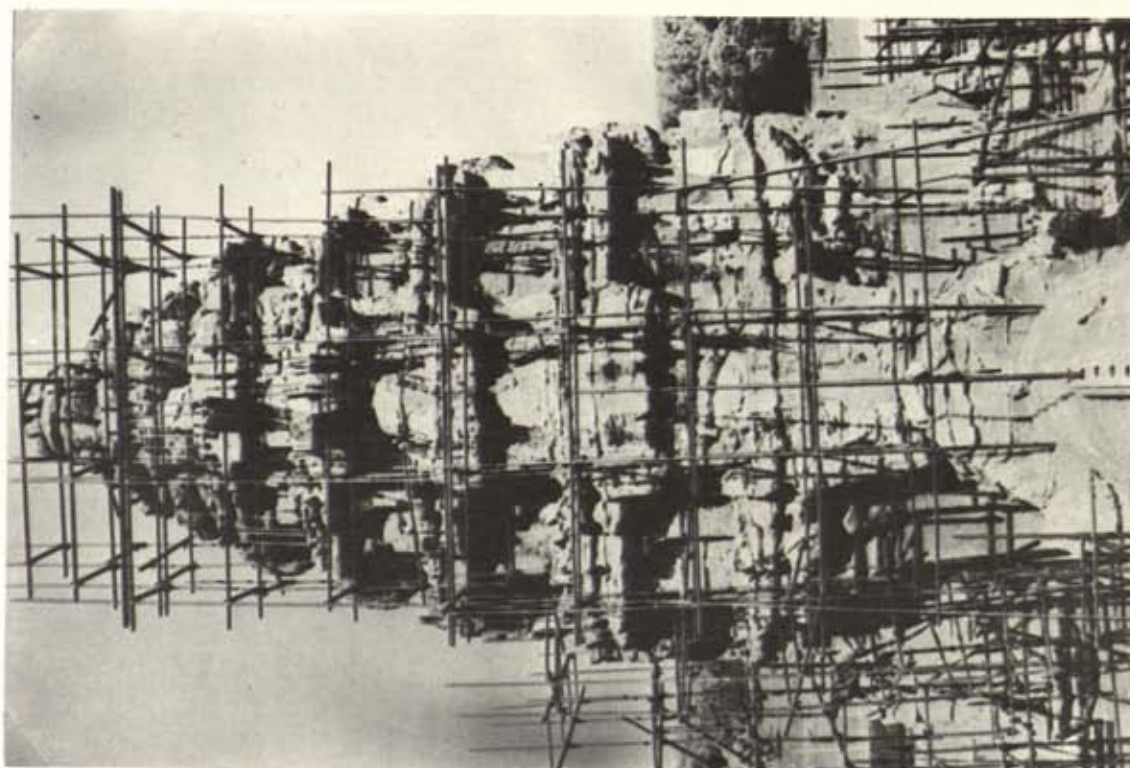
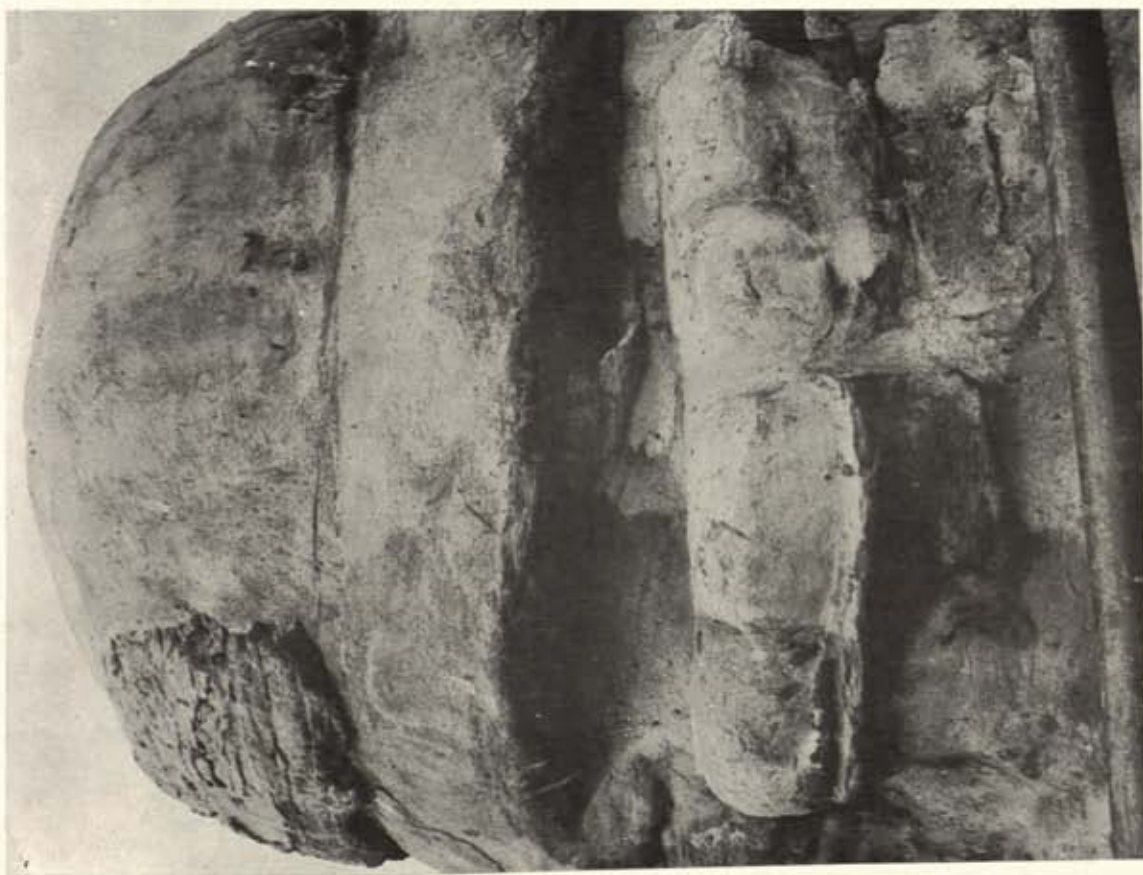
First Enclosure : north-west corner tower, A, during and B, after conservation

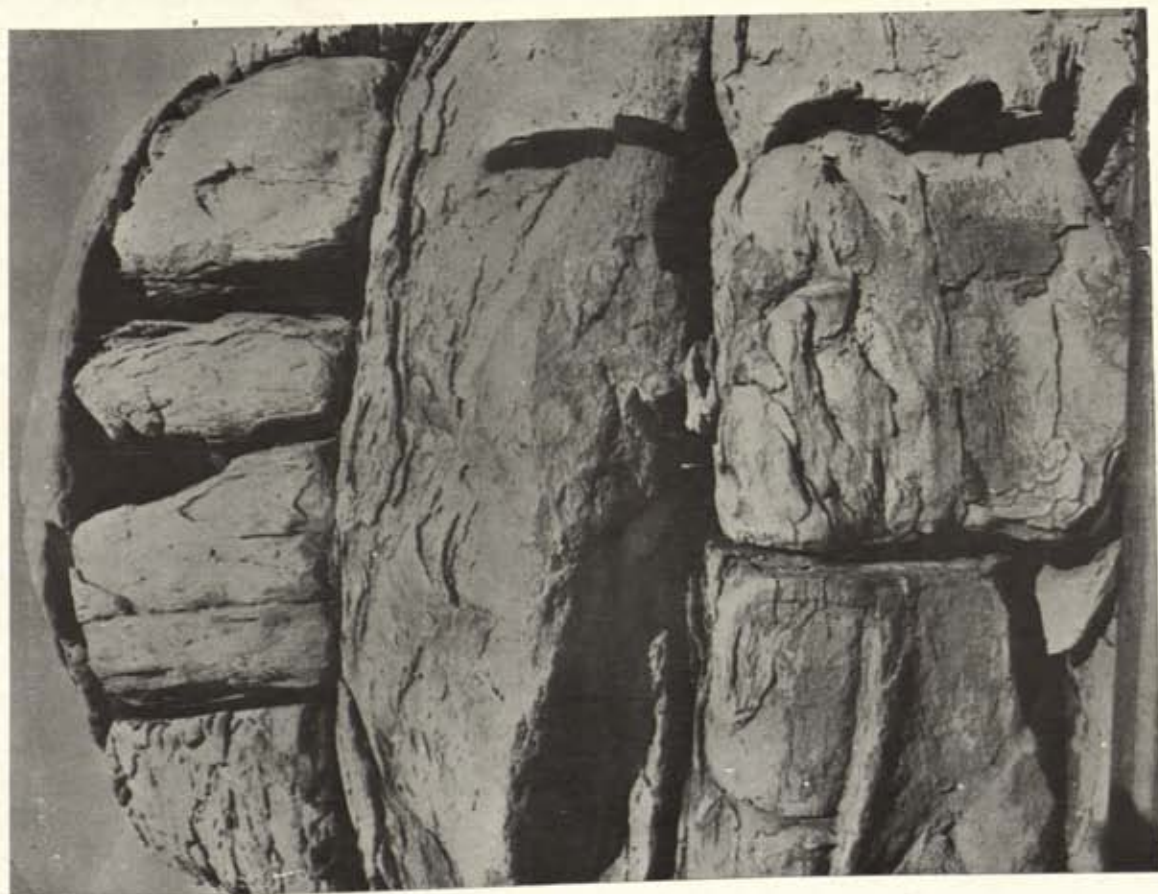
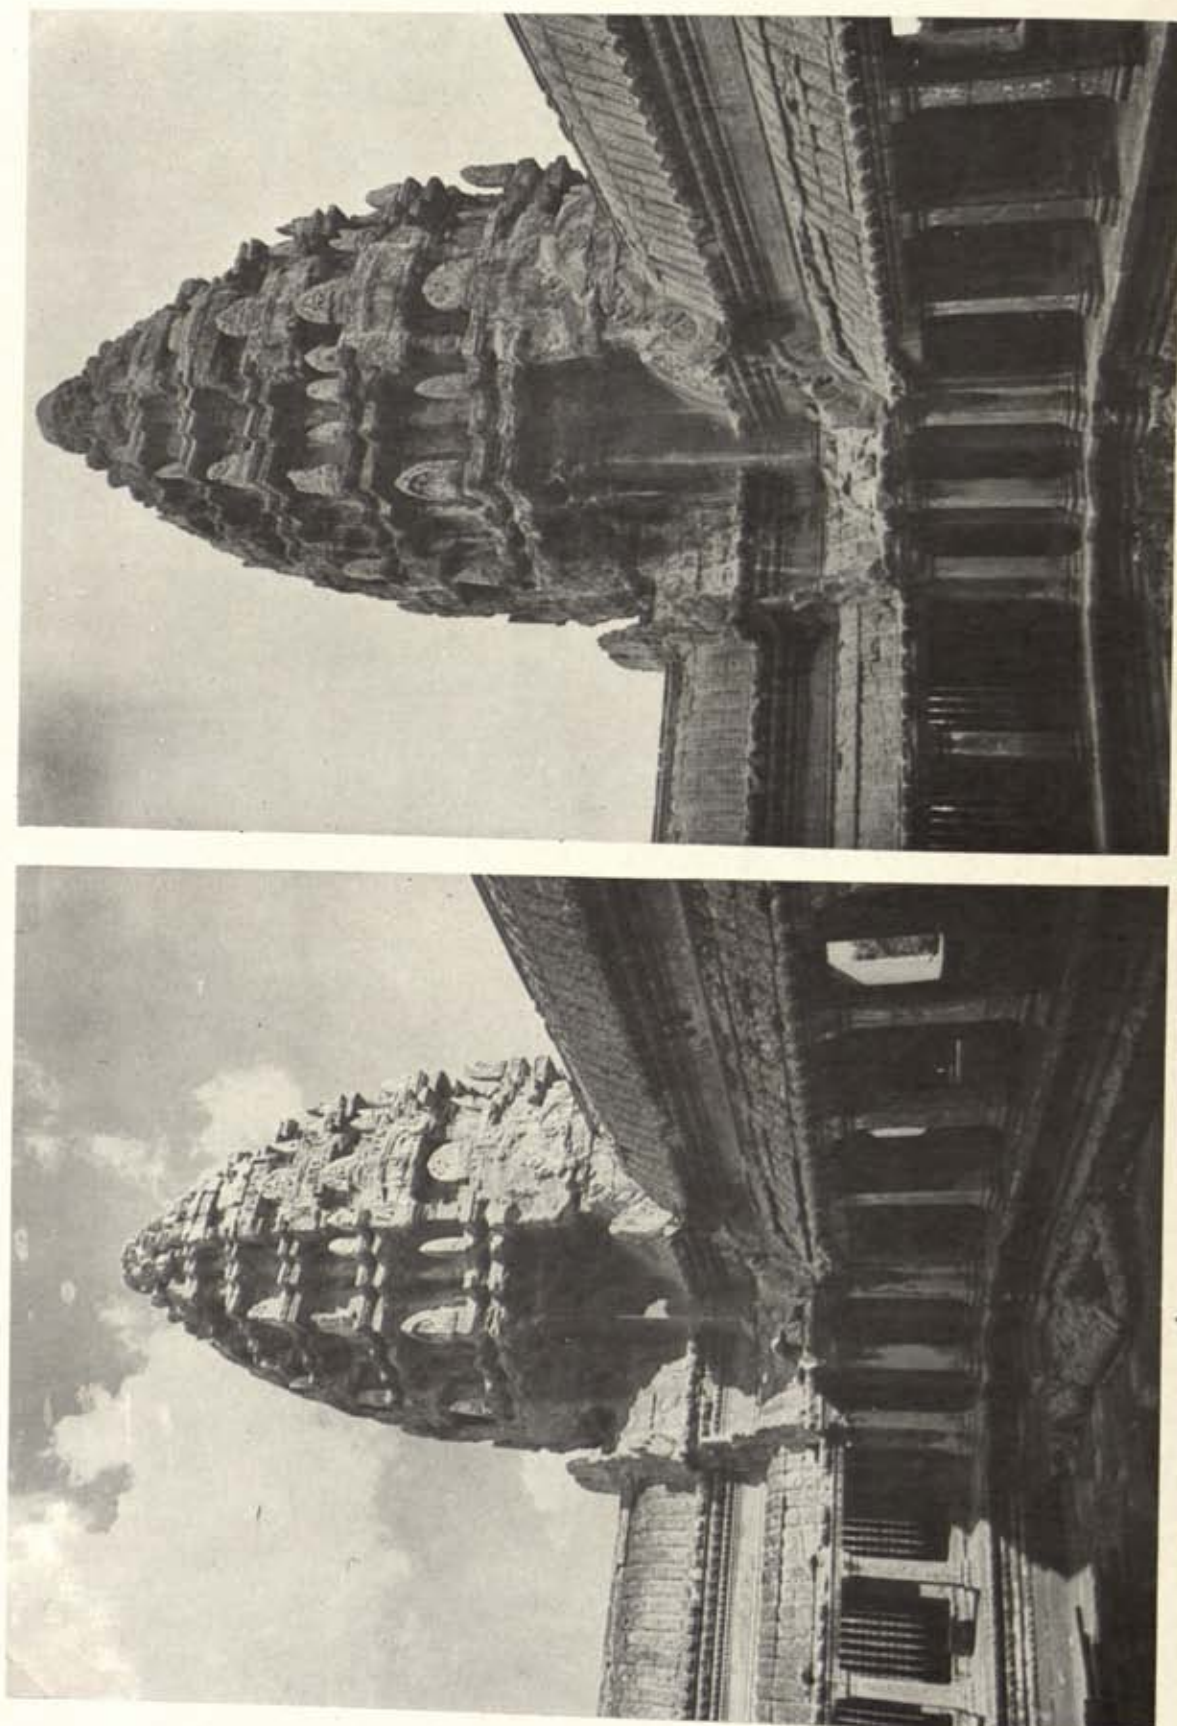
First Enclosure : north-west corner tower, A, before and B, after conservation and chemical treatment
